<b>Subject:</b> <b>BLIND SPOT MONITORING (BSM) DOES NOT OPERATE AFTER REPAIR</b>	<b>Service Alert No.:</b> SA-013/18
	<b>Last Issued:</b> 06/06/2018

2017-2018 CX-5

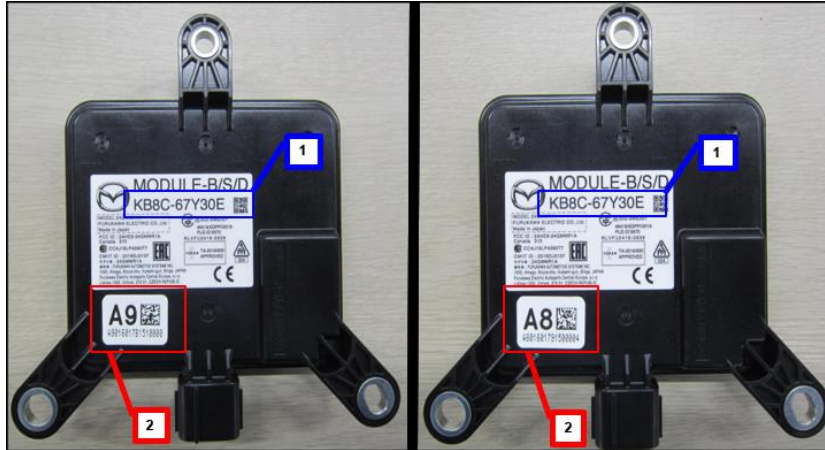
Some customer's may complain that the blind spot monitoring (BSM) is not operating, and the key ON bulb check is OK with no DTCs stored in memory. This issue could be caused by mis-matched BSM modules, especially if the vehicle was recently involved in an accident or work was done on the BSM system. To check if this is the issue, refer to the Repair Procedure.

2. Inspect the labels (1) on the BSM modules:

- If both modules have part numbers that are KB8C-67Y30E (suffix E) or lower, proceed to next step.
- If any module has a part number that is KB8C-67Y30F (suffix F) or later, this service information does not apply. Suffix F or later mismatch is OK.

3. Inspect the labels (2) on the BSM modules (P/N KB8C-67Y30E).

- If one module has 2 digit alphanumeric label with "A8" and the other has label "A9", replace the "A9" module with an "A8" module (if the P/N is KB8C-67Y30E) or with P/N KB8C-67Y30F (suffix F) or later. "A9" modules have been quarantined and only KB8C-67Y30F (suffix F) or later modules are available from Parts Inventory.
- If both modules have the same 2 digit alphanumeric label (both have "A8" or "A9" labels), this is not the issue. Refer to BSM troubleshooting procedures on MGSS.
