Mazda B2200 Fuel Sender Replacement

Written by Cusser

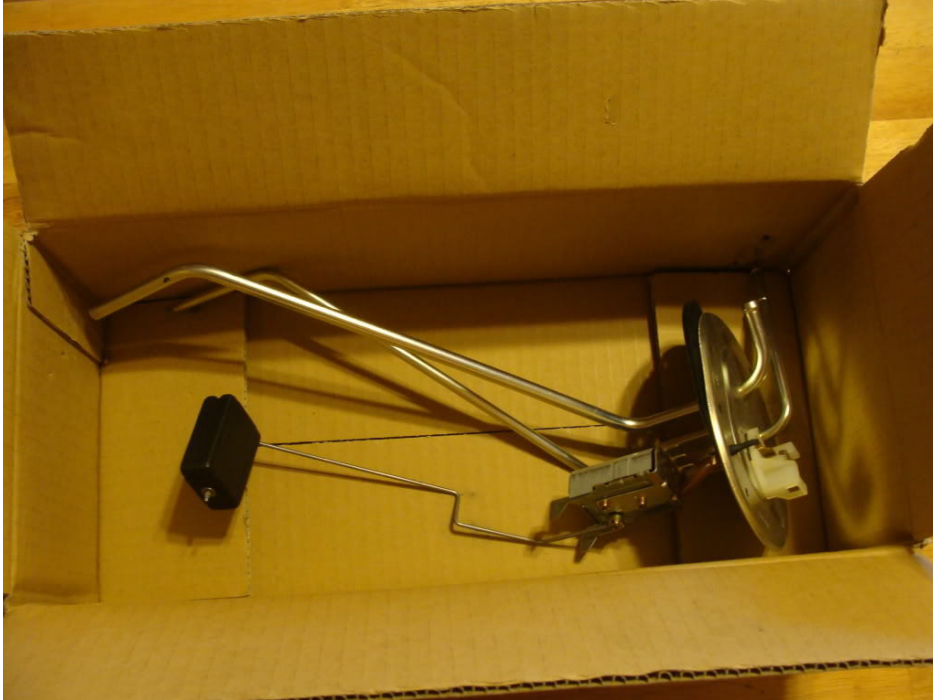
Disconnect cable release and pull rearward through the hole, and loosen the cable clamps on the hoses that connect on the metal fuel filler.

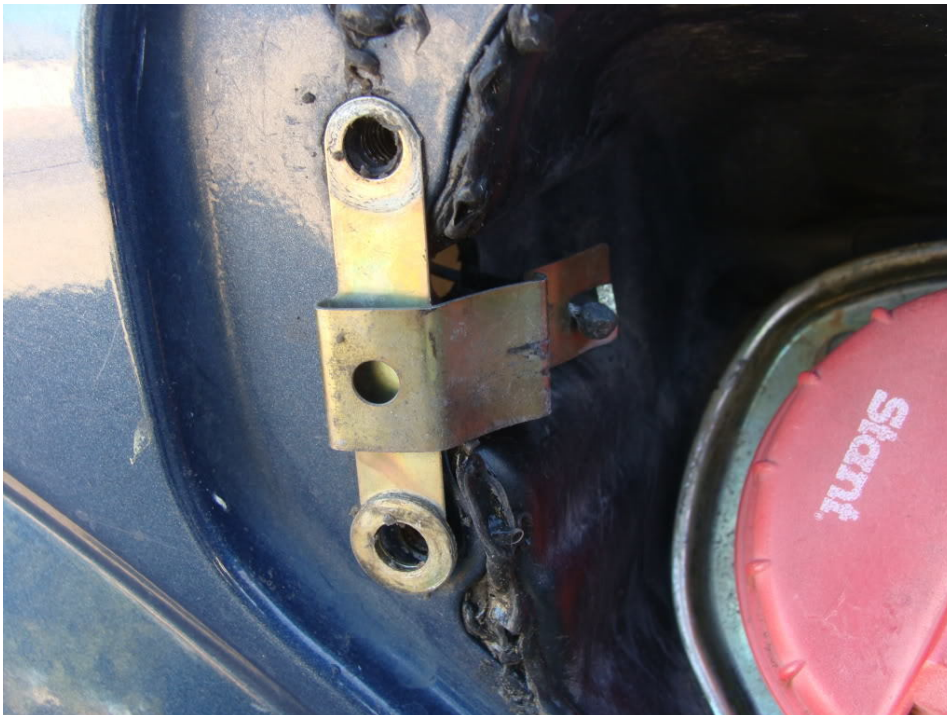
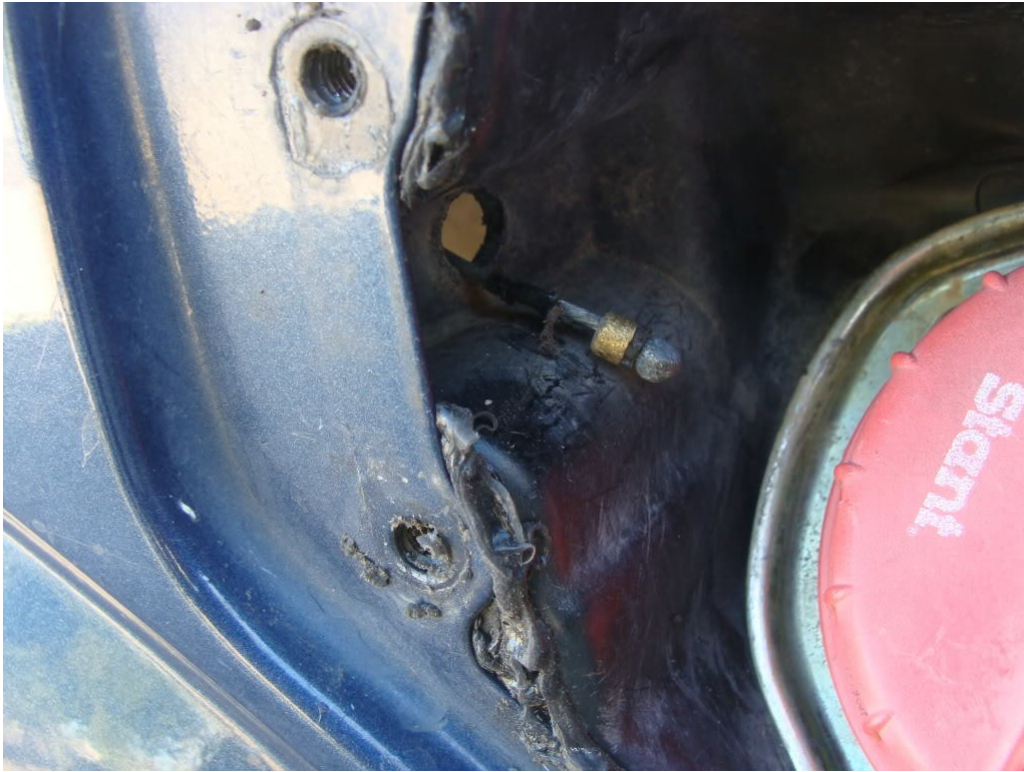
Remove the three 17mm-head bolts on the passenger side bed frame. Loosen the corresponding bolts on the driver's side, about about 2/3 of the way.

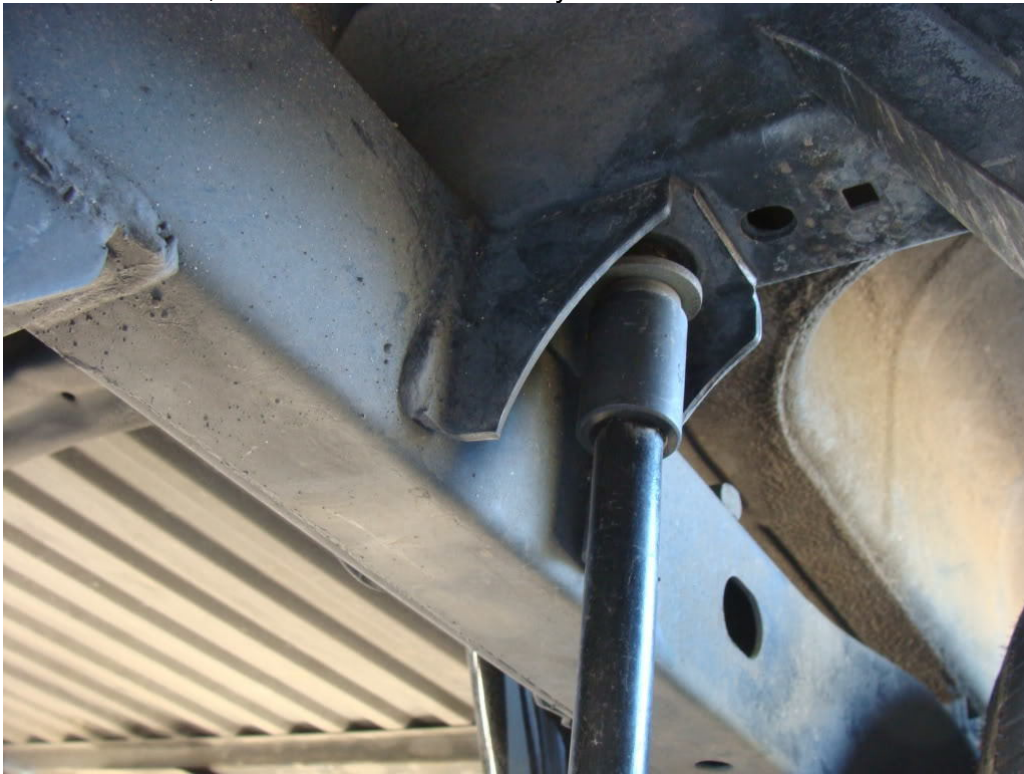
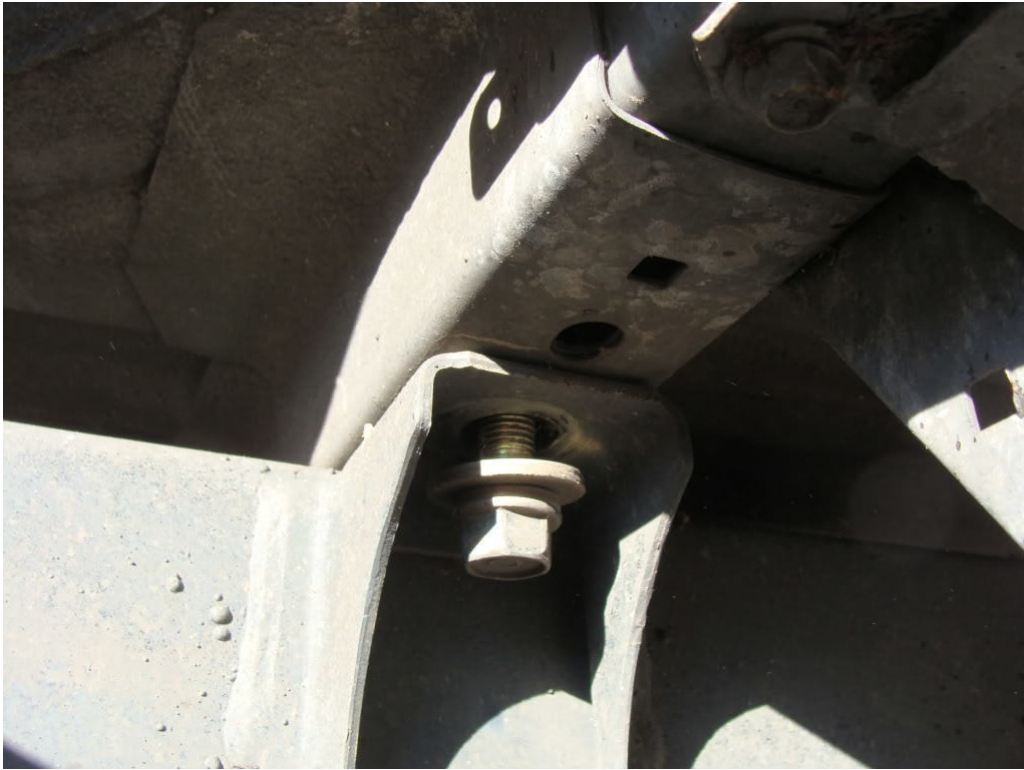
Use a 16 inch 2 x 4 on a floor jack to lift up the passenger side of the bed. Tighten the jack, tilt the bed up a little.

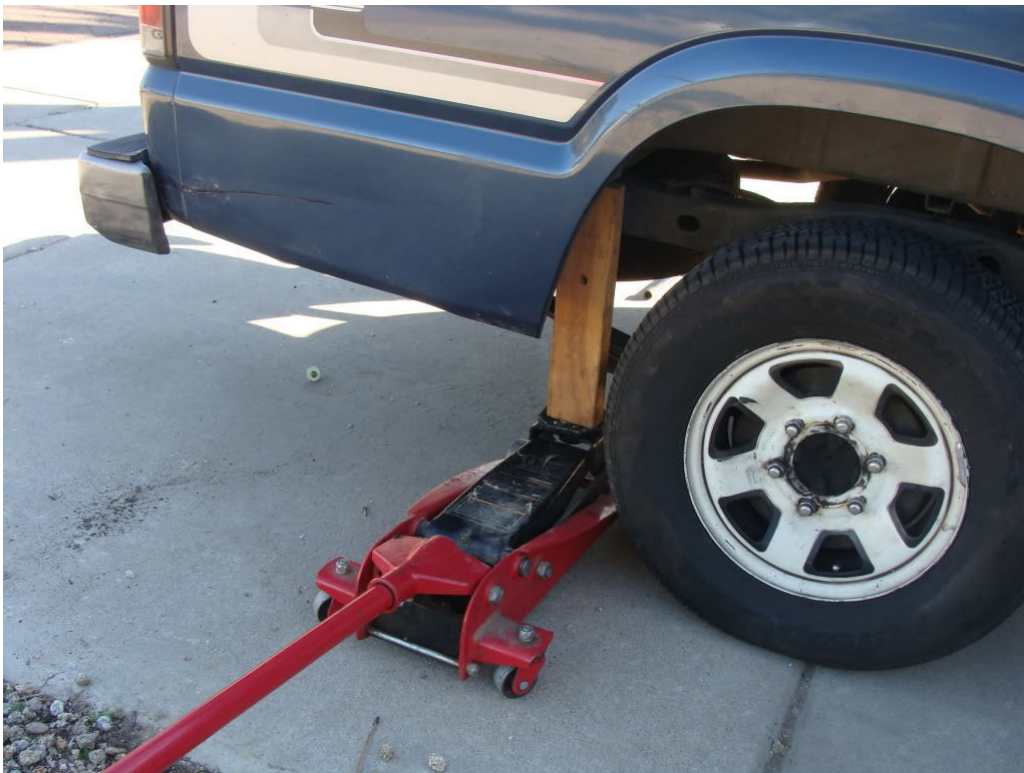
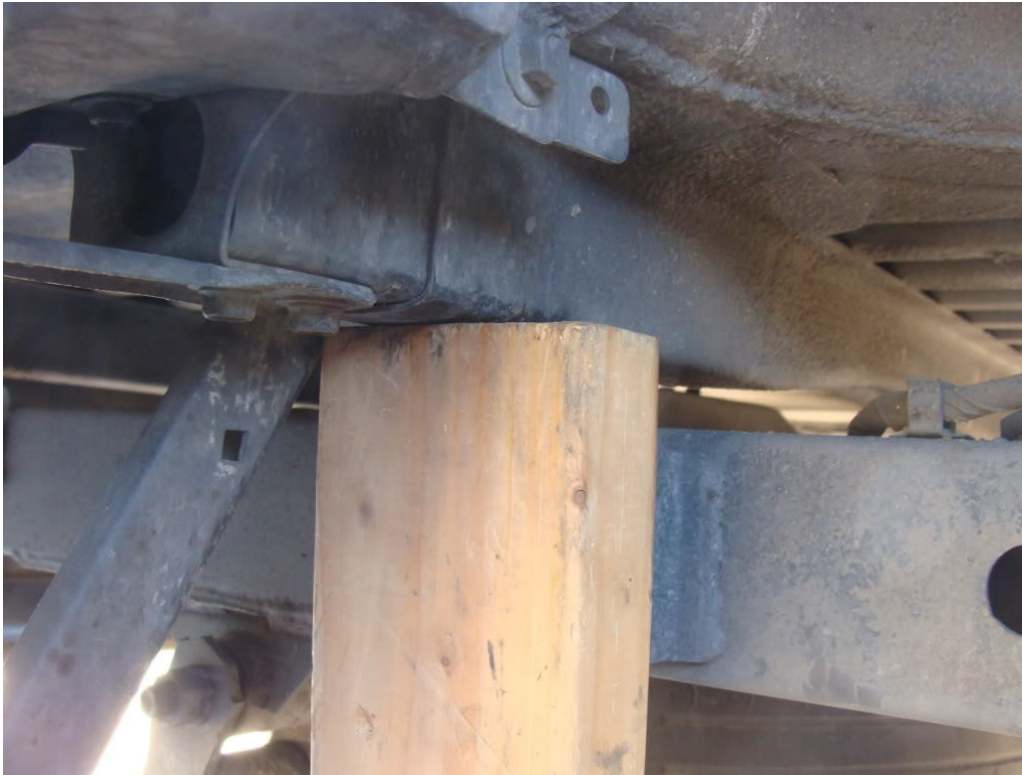
Disconnect the two rubber hoses at the gas fill assembly; I used a large whale-shaped Vise-Grips #LC-12 to loosen/remove the larger one.

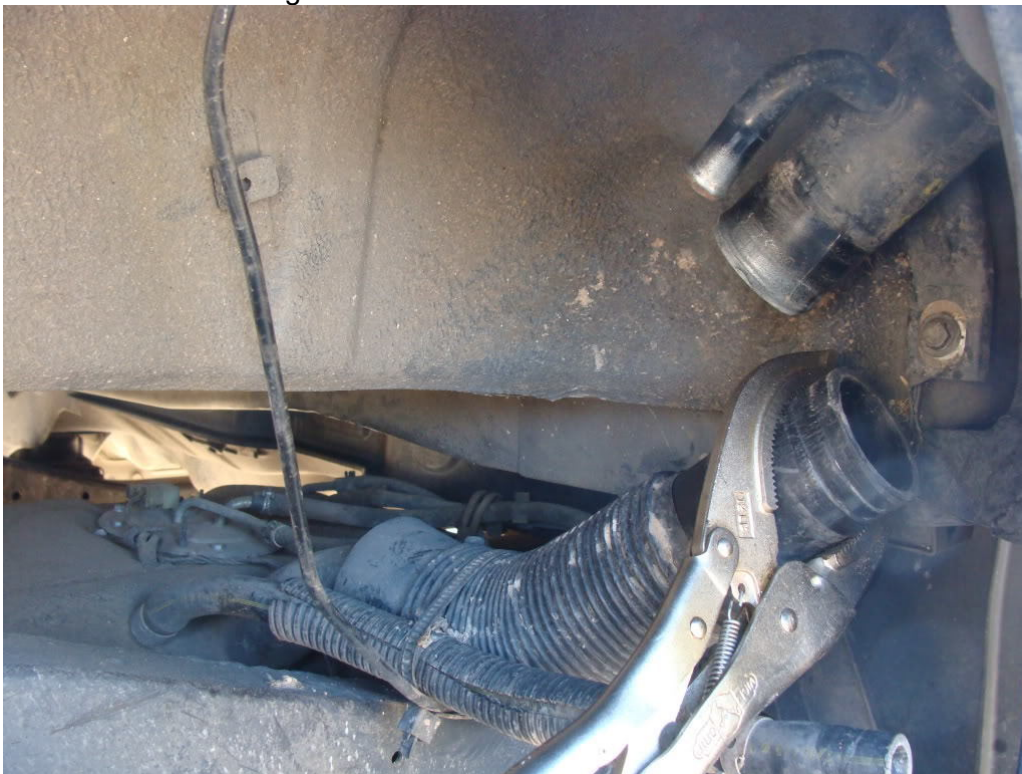
Jack up the truck bed more. Remove the two hose clamps and hoses. Remove the electrical connector. Loosen the sending unit attaching screws.

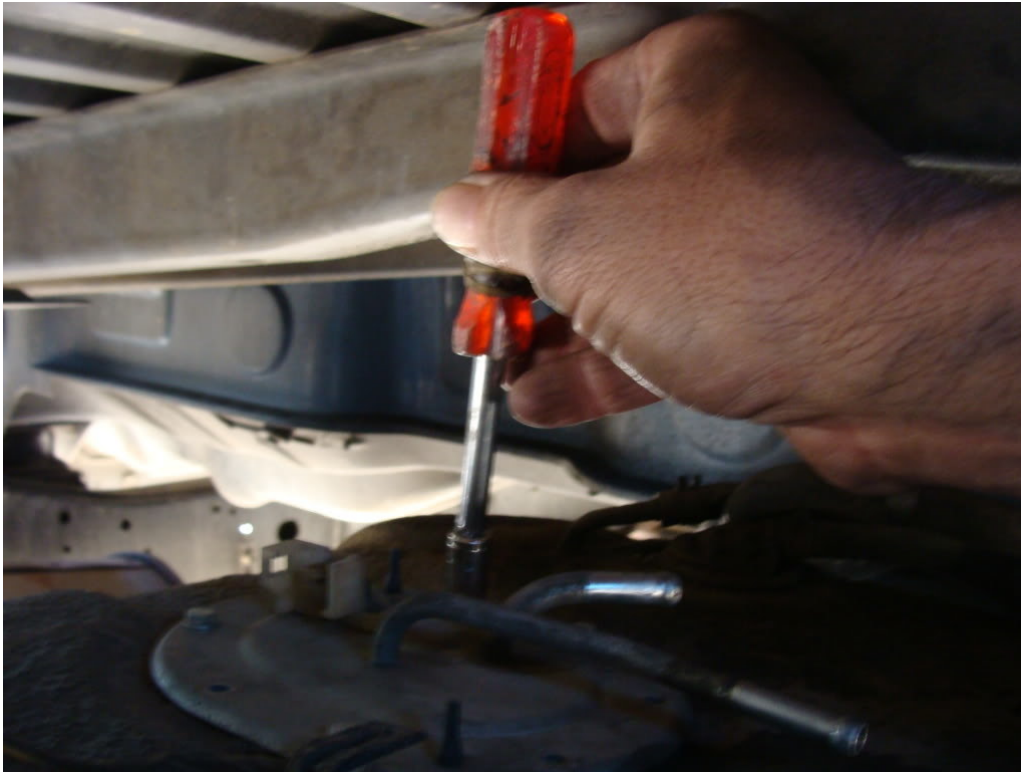
I already have 7mm head hex head screws from Ace Hardware (4mm thread x 8mm long, with a wavy washer) on my sending unit from last time, recommend that. If you have the stock screws, use a 1/4 inch drive ratchet, with 1/4 inch socket and a #2 Phillips bit (and two hands to hold it straight). Then lift out the old sending unit, tilting it for clearance.

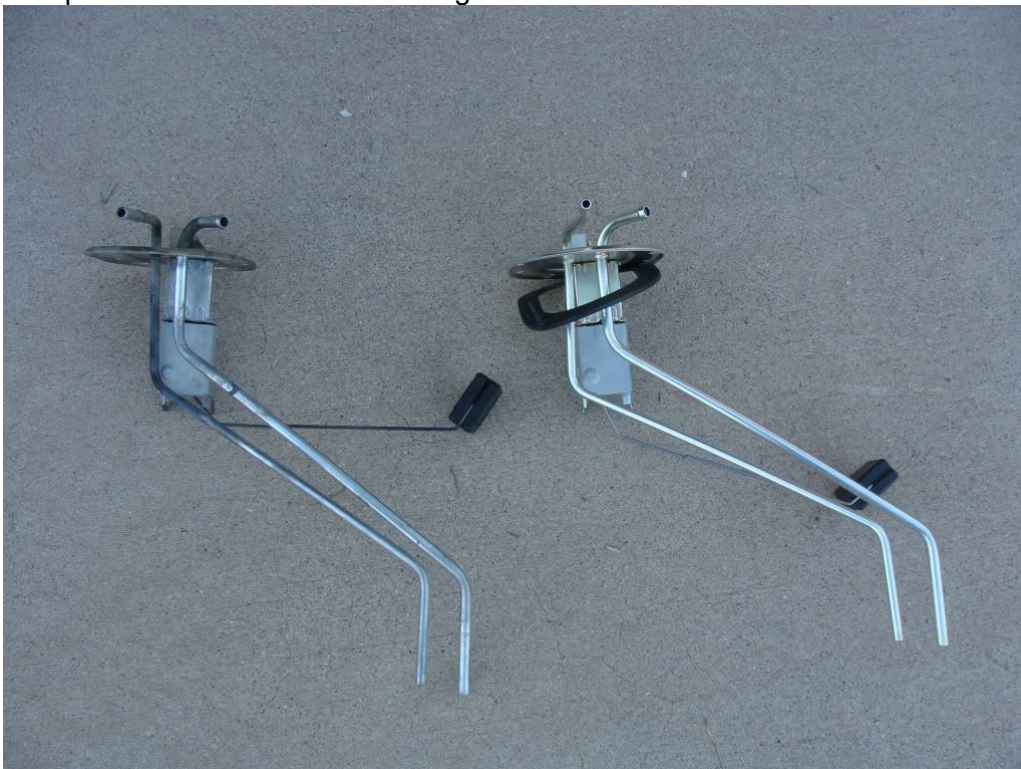
Comparison of old and new sending units.

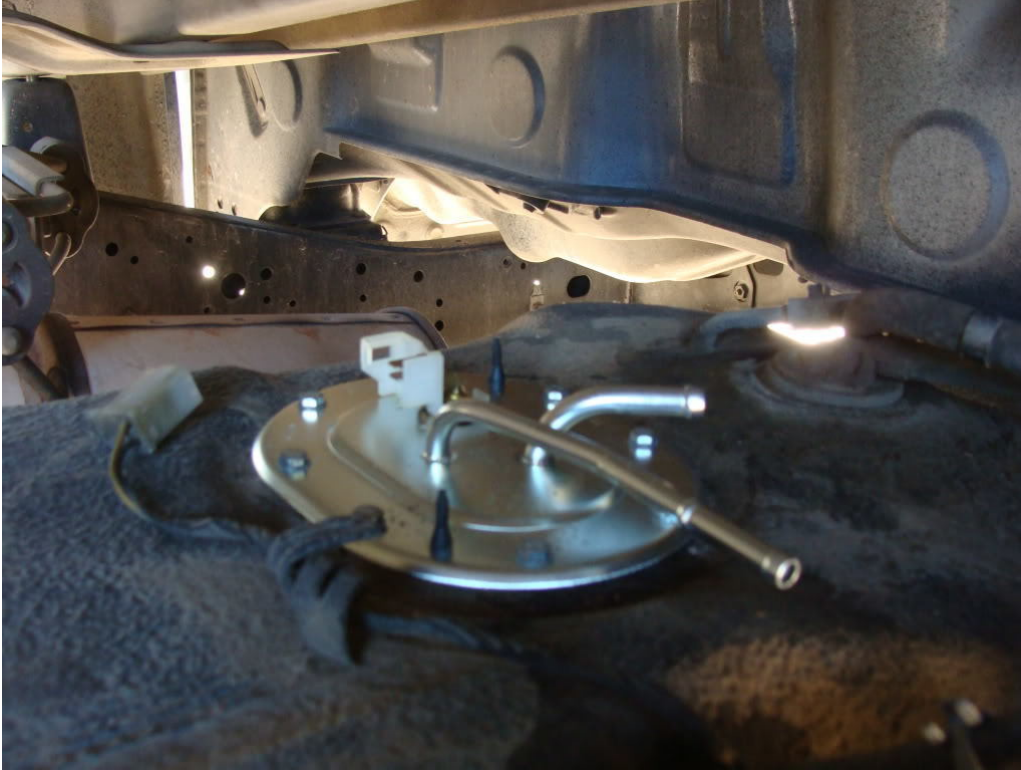
Checking ohms; there were open regions on the old sending unit with no resistance as I moved the float through the arc. New factory unit was graduated resistance, like it should be, with no opens.

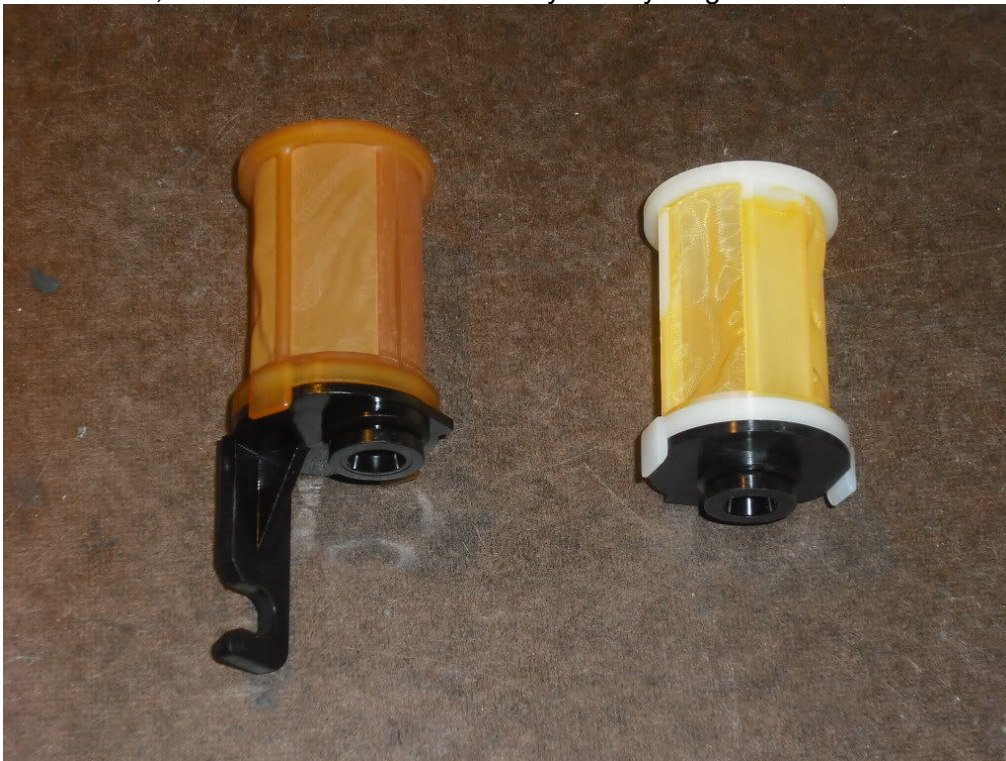
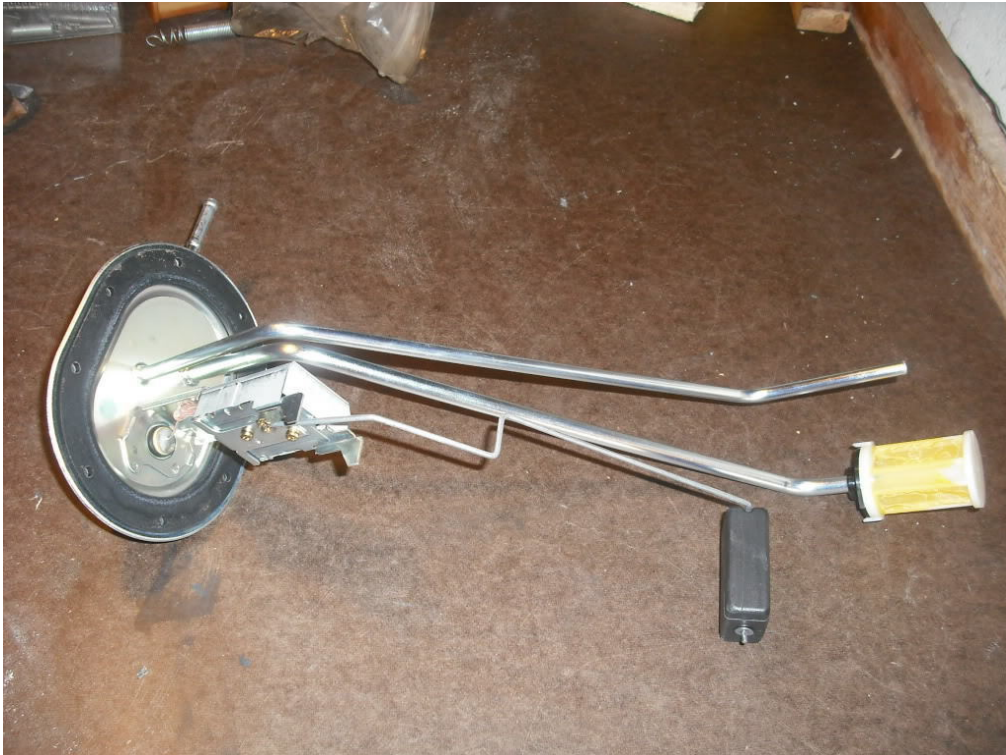
New sender installed, using the new rubber gasket which was included. New fuel sock, also from Dan Atkins used, as the stock one wouldn't stay on any longer.

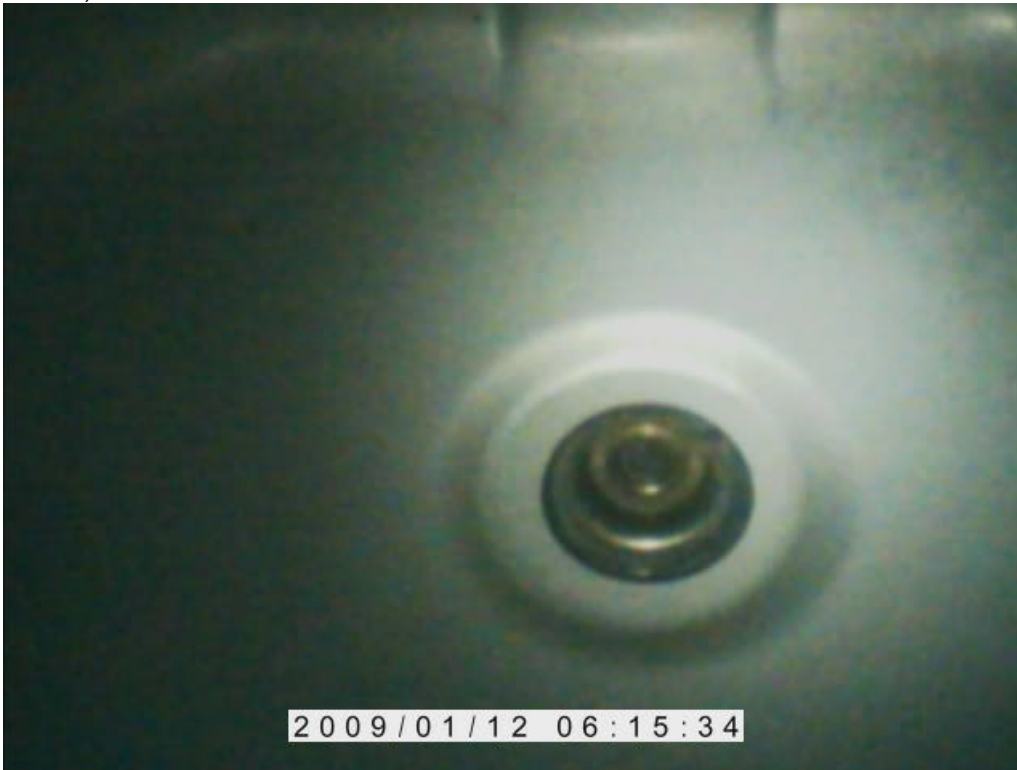
Photo of inside of fuel tank, using special inspection camera, a gift from daughter. Photo shows no rust or debris, GOOD !!!

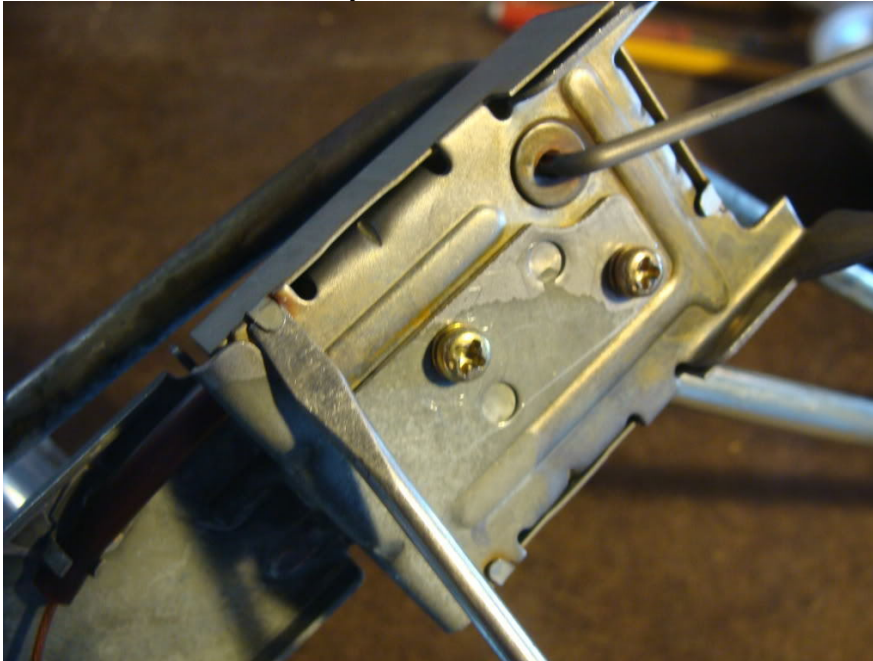
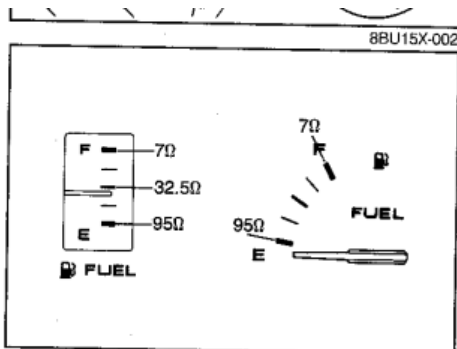
If one was going to try to clean the old unit and bend the contact arm (like I did a few years ago), do NOT remove the two screws. Pry back the three little tabs and slide the cover off for access.

3. Set the checker to the resistance values shown in the figure.
4. Turn on the ignition switch, and make sure the needle indicator displays the correct values.
If it does, the trouble is in the fuel tank unit; if it does not, the trouble is in the meter.

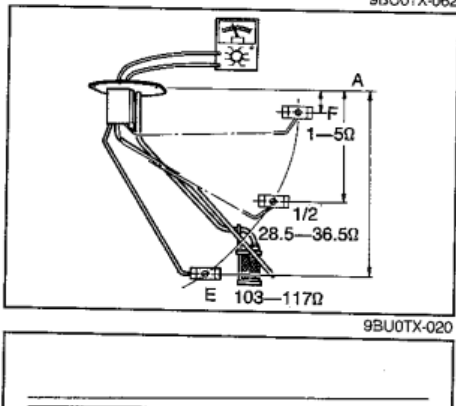
Fuel Tank Unit

1. Connect an ohmmeter to the tank unit.
2. Move the unit arm slowly from point (E) to point (F) and read the resistance value. If this value is outside the standard range, replace the unit.

Height		A—F	A—1/2	A—E
Standard	Short	44 ± 2.5mm (1.73 ± 0.1 in)	158mm (6.22 in)	263.5 ± 2.5mm (10.37 ± 0.1 in)
	Long	54 ± 2.5mm (2.13 ± 0.1 in)	163mm (6.42 in)	260 ± 2.5mm (10.24 ± 0.1 in)
Cab Plus		91 ± 2.5mm (3.58 ± 0.1 in)	181mm (7.13 in)	263.5 ± 2.5mm (10.37 ± 0.1 in)
